Corrosion Evaluation of Glass Fiber Reinforced Plastic (GFRP) Tanks & Pressure Vessels Using Acoustic Emission Technology

Abstract. IREINE project (Innovation for the Reliability of Industrial Equipment) is a study conducted by Arkema, Technip and UTC to develop an innovative NDT (Non Destructive Testing) methodology using acoustic emission (AE) to evaluate active corrosion on Glass Fiber Reinforced Plastic (GFRP) structures. GFRP equipment is widely used in the chemical industry, especially for storage of corrosive products. Failure of such equipment can have important impacts on people safety, environment and production matters. Hence, it is essential to have a technique to ensure reliable detection of damages. The experimental work presented in this paper was aimed at investigating the ability of AE technology for evaluation of corrosion phenomena in GFRP structures. This paper describes the experimental program including field experience on full scale tanks, laboratory results and analysis of the dissection of tank structure.

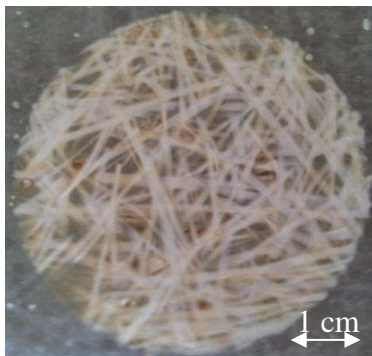
Fig. 3. Picture of consequences of the corrosion on GFRP

Further investigations have been made on the corrosion of composite by hydrochloric acid. Mineral acid like hydrochloric acid is known to react with the glass fiber. The corrosion of glass fibers in mineral acid solution is less known but very important. Indeed, this corrosion is thought to be responsible of GRP failure (Figure 3).

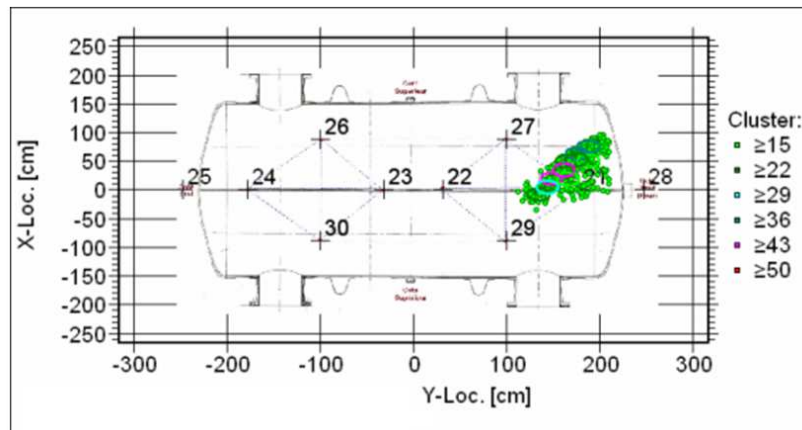
Fig. 8. Planar localization of AE events during the passive monitoring.

The analysis of the data from the 2 hour passive monitoring was based on classical methods like amplitude distribution, activity chronology and source localization. The figure 8 shows the planar localization of the AE events, using an algorithm based on the arrival-time differences. The events are localized in the developed plan of the tank structure. One can identify an area highly concentrated in AE events, close to the sensor C21 (more than 50 events in a 25cm x 25cm section). In addition, the chronologic trend of these events is consistent with a natural phenomenon (non-linear but continuous phenomenon). The analysis has led to the conclusion that the localized area close to the sensor C21 is probably related to corrosion of the tank structure.

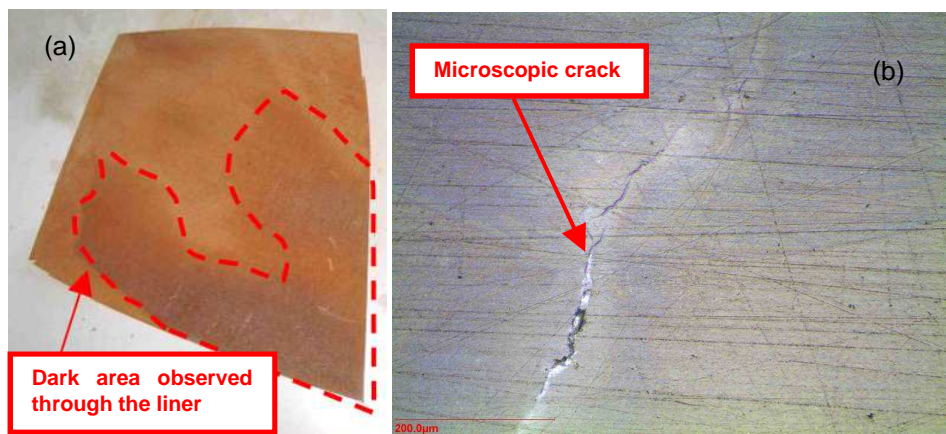
Fig. 9. Inspection of the PVDF liner (a) visual (b) micrography

After AE measurements, the tank was removed from service, dissected and inspected. The inspection was focused on the emissive area detected and localised during the AE passive monitoring. The figures 9(a) and 9(b) illustrate the observations performed on the internal PVDF liner. The visual inspection, figure 9(a), shows that the internal surface of the liner is colored because of the bromine migration, but no macroscopic crack or blister is visible. Micrographic examination, figure 9(b) reveals some micro-cracks, close to the weld seams.

The PVDF liner is fixed to a synthetic fiber fabric which provides the adhesion between the liner and the GFRP laminate. In the emissive area, the liner is easily detached from the laminate; some bromine spots are visible at the interface liner/laminate. In the non-emissive area, the liner is well attached to the laminate. No bromine spot is visible at the interface liner/laminate.

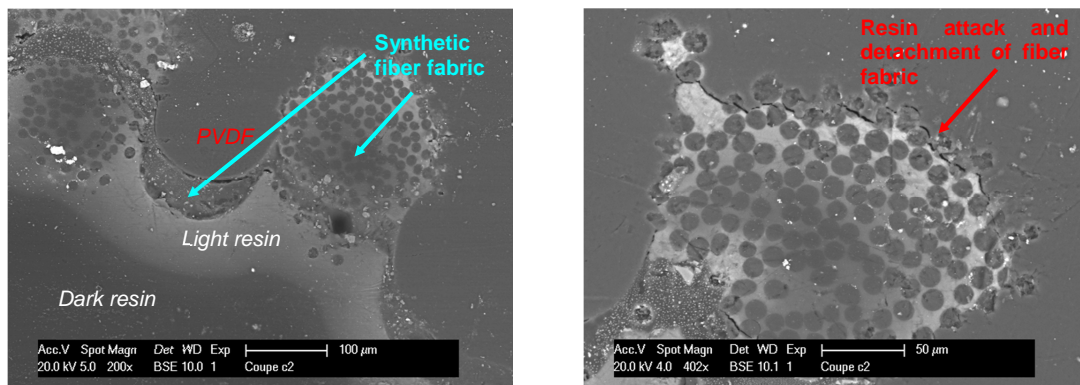
Fig. 10. SEM pictures of the interface liner/laminate

Scanning electron microscopy with energy dispersive X-ray spectroscopy (SEM/EDX) investigations were performed on the interface between the liner and the laminate (figure 10 and table 3). The analysis of these investigations shows a slight diffusion front ($\approx 100\mu\text{m}$) of bromine in the resin of the laminate. This attack of resin is related to the detachment of the PVDF from the laminate.

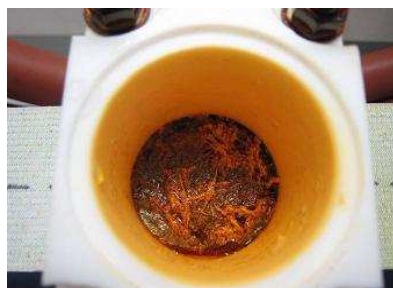
Fig. 11. GFRP specimen after corrosion test with bromine

Corrosion tests were performed on GFRP specimen in contact with bromine, monitored with 2 AE sensors. The dimensions of the specimen are 50 x 300 mm, cut from a healthy area of the dissected tank. The PVDF layer is removed from the specimen. No surface treatment is done (the synthetic fiber fabric is still present). Figure 11 shows the specimen after the corrosion test.
