Real Time & Long Term Acoustic Emission Monitoring: A New Way to Use Acoustic Emission - Application to Hydroelectric Penstocks and Paper Machine

Philippe BRYLA *, Henri WALASZEK **, Catherine HERVE **, Johann CATTY **
* EDF Division Technique Générale, Grenoble, France
** CETIM, Senlis, France

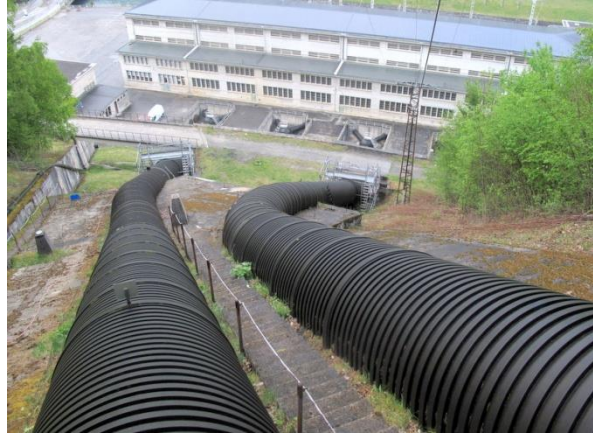
Picture 1: General view of the double hooped penstock

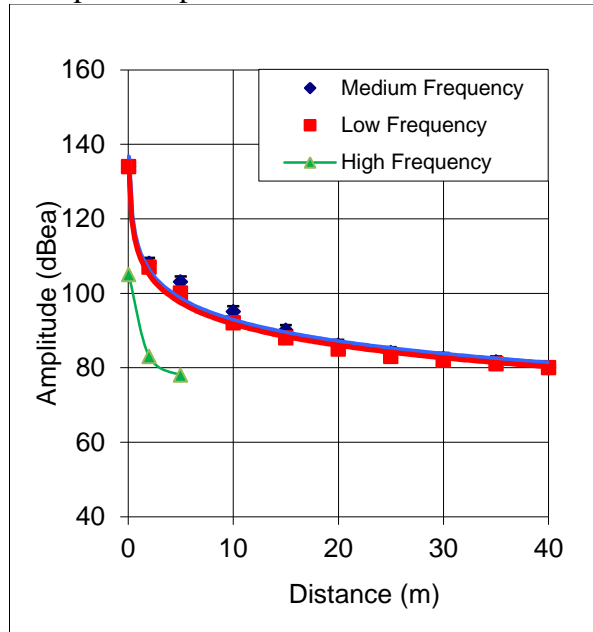
Graph 1: AE Attenuation curves vs. Frequency

Thus, from the outcome of these attenuation and background noise measures, we were able to define a mesh for a complete coverage of the penstocks sections to be monitored.

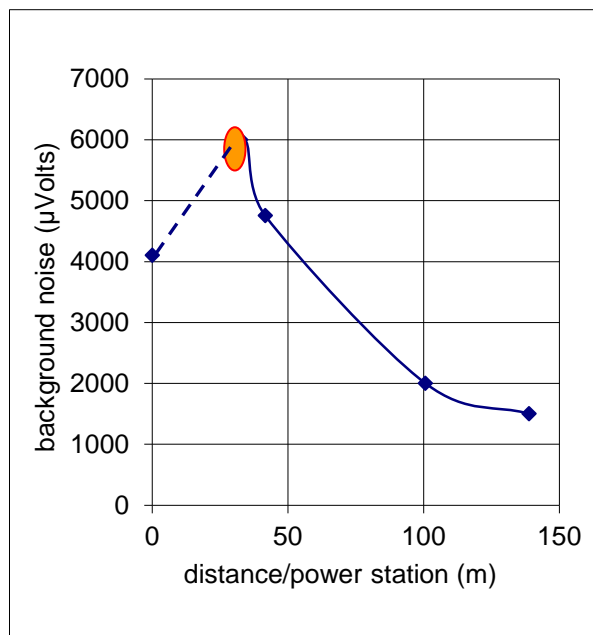
Graph 2: Background noise vs Distance from the power plant

These measurements showed (graph 2) for example that the level of noise depends on the distance from the turbines, and also on the presence of elements such as fluid distribution spherical parts.

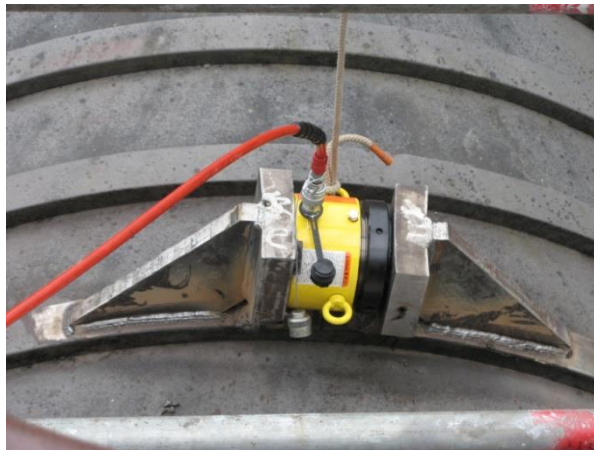
Picture 2: Rupture test of a forged hoop–Hydraulic System

Rupture tests were carried out on three rings. To be as representative as possible of a rupture that may occur in service, the three rings being tested were previously notched with a grinder, gussets were welded on the ring in order to install a cylinder jack (see Picture 2). Thus, it allowed performing ruptures without noise. So that the propagation of acoustic waves should be representative of a normal operation situation, the lower sections of the penstocks were partially filled with water during the tests. The acoustic signal emitted by each of these three breaks was then measured by the instrumentation in place.

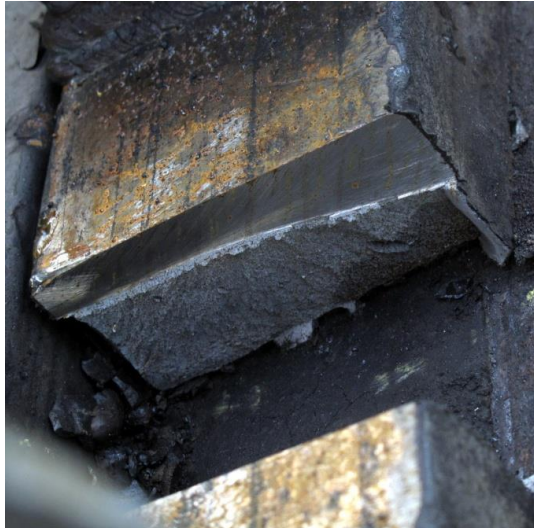
Picture 3: Rupture test of a forged hoop– Fracture Surface

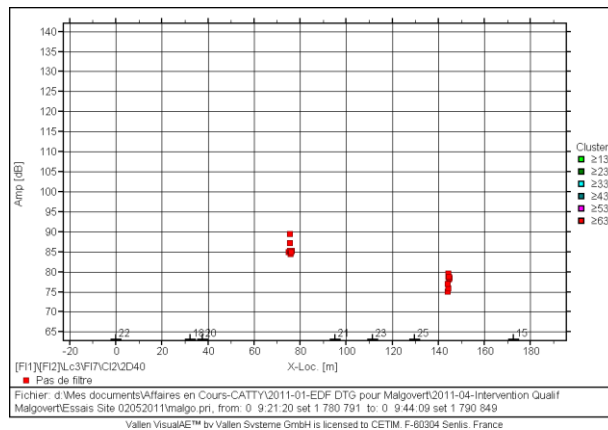
Prior to rupture tests, the artificial acoustic emission sources have been generated at the ring positions to be broken in order to assess the ability of the localization system; For this, a linear mesh was used (Graph 3).

Graph 3: Pre-localisation of failures by artificial source, linear location algorithm

All provoked ruptures were localized with an accuracy of the order of 2 m, for distances between sensors up to 60 m.

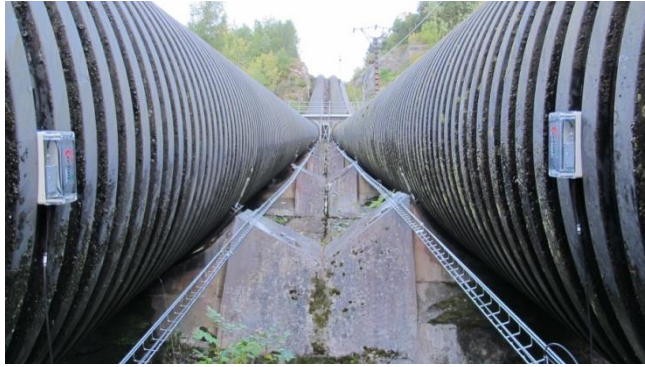
Coaxial cables were pulled from each sensor to the acquisition system, located in the building of the hydroelectric plant. Almost 3,000 meters of cables were installed.

Picture 4: Cable path, and 2 boxes including sensor and pre-amplifier

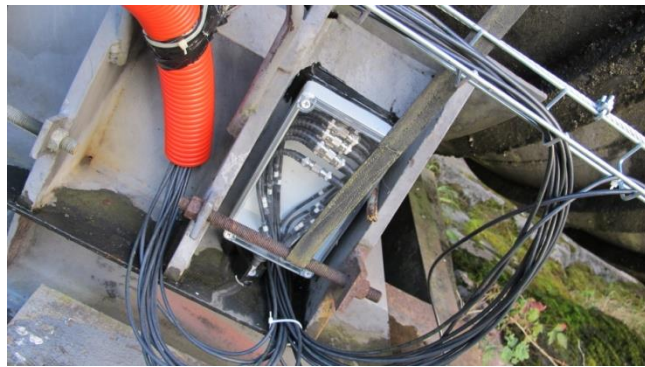
Picture 5: A connexion box

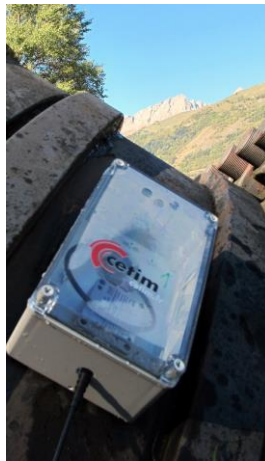
Each sensor has been protected by a plastic box, also integrating the first amplification and filtering stage.

Picture 6: Sensor's Box

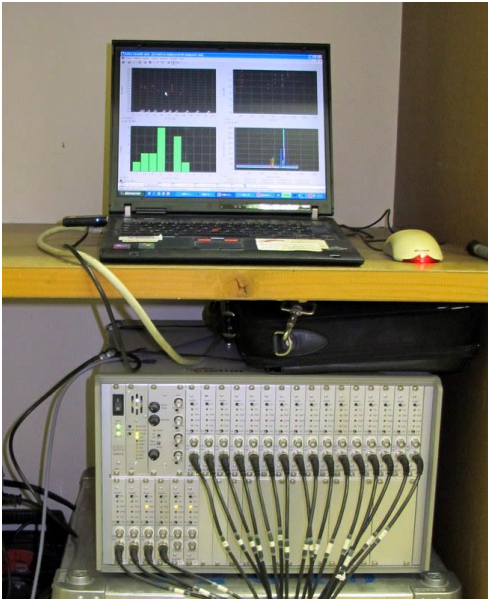
An acquisition system 'VALLEN Amsy-5' was set up in the building of the plant. To assess the impact of weather conditions on the observed data, a multi-parameter weather station was installed, allowing the measurement of temperature, precipitation rate, wind.... This monitoring system fully ensures its function as it generates alarms in real time, and prevents the on-call personnel so that it can trigger appropriate actions. Therefore, the

Picture 7: Valen Acquisition System

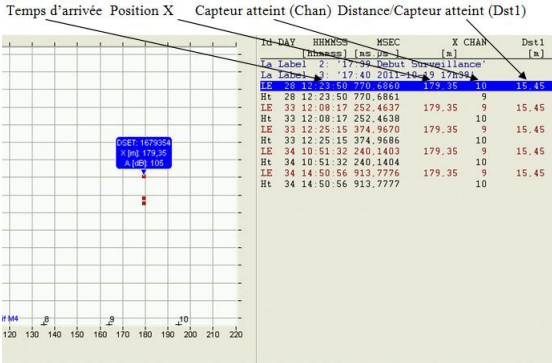
Graph 4: Monitoring Screen, showing an AE event, and its characteristics

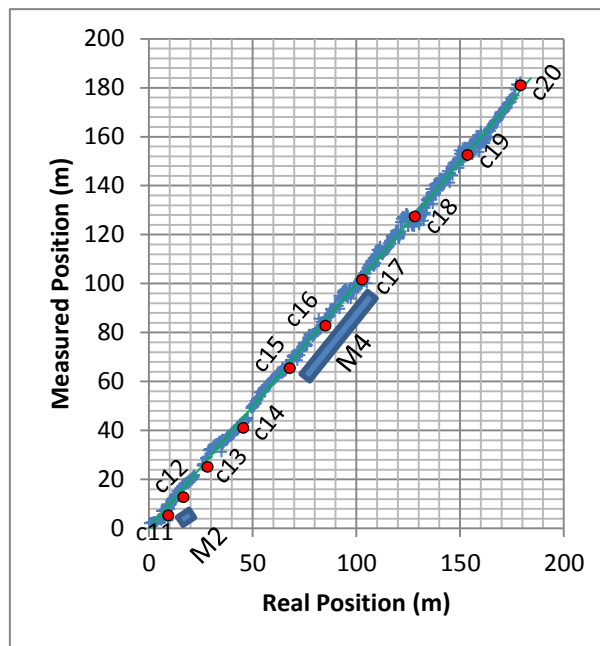
Thus, more than 1,000 sources were generated and analyzed (graph 5). The average absolute deviation to the theoretical position is about 1.30 m; Approximately 90% of the measurements shows a difference of less than 2.5 m.

Graph 5: Correlation between true position of the sources and calculated positions from AE signals.

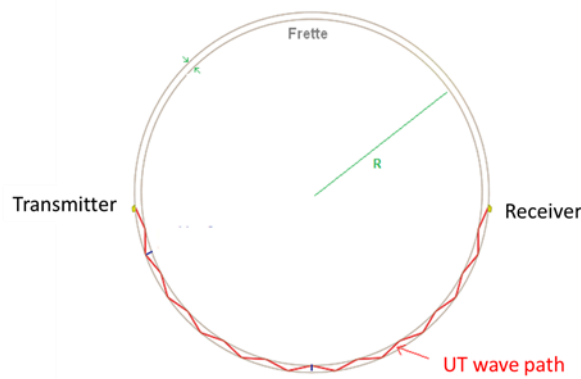
As such events must be considered as potential ring failures, technicians immediately investigated to confirm or not the indication detected. To this end, a first visual inspection focused on the area localized by AE is achieved. When the acoustic event is localized on rings which are partially embedded in the concrete, integrity must be checked by ultrasonic testing (UT) for every rings located in the emission zone. This control is achieved with an oblique UT device using separated transmitter and receiver: the measurement consists in transmitting a signal from one side of the hoop and recovering the transmitted signal at the opposite side, having undergone by successive bounces. The reception of the ultrasonic signal is interpreted as an absence of failure.

Picture 8: UT NDE of a hoop

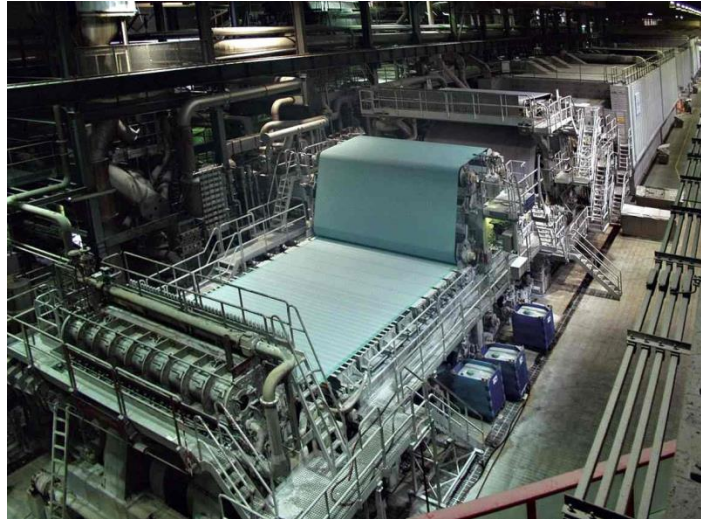
Picture 9: General View of the Paper Machine, CONDAT

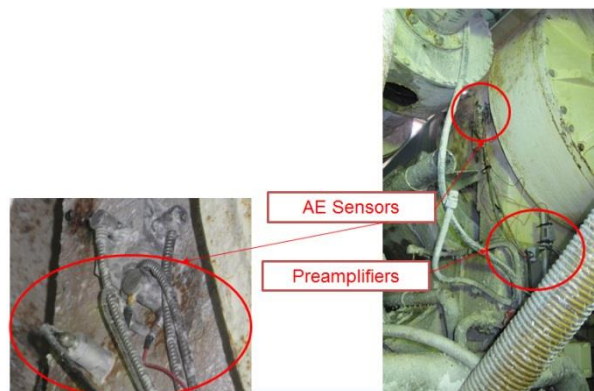
Picture 10: AE Sensors installed on a bearing of the suction roll

The three types of sensors (piezoelectric sensors) are attached to the mechanical parts by a specific glue (cement X60). The surface is prepared before the installation (cleaning and sanding).

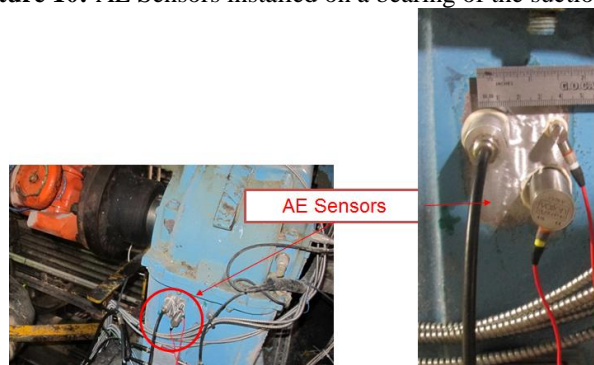
Picture 11: AE Sensors installed on a gearbox

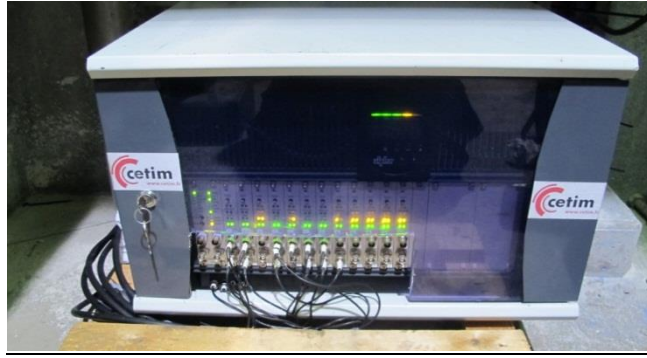
Picture 12: Vallen Acquisition System + Inverter + PC

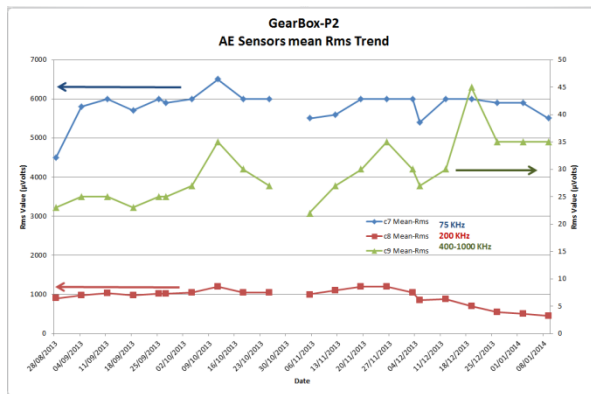
Graph 6: General trend of AE Rms value coming from 3 types of sensors, Gearbox.(5 months)

The analysis of AE data and the conclusions we can extract from depend on the time scale. If we globally observe AE data on a period of 5 months, we will not be able to find very thin evolutions. Then, we could conclude to very stable values ... At the contrary, if we only analyse a “short” period, for example one day, we could conclude sometimes, to very instable AE activity (see graph 7).

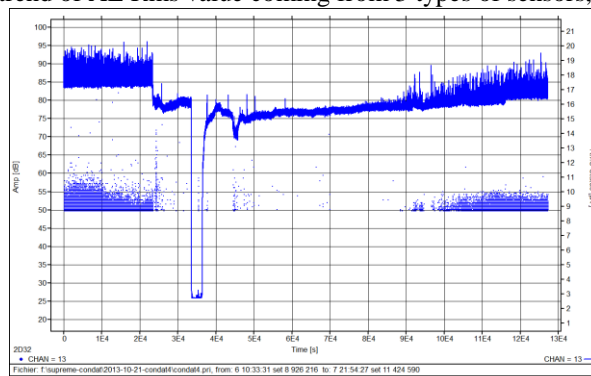
Graph 7: AE Sensor RMS Trend and AE Hits between the 2nd and the 3rd of October 2013

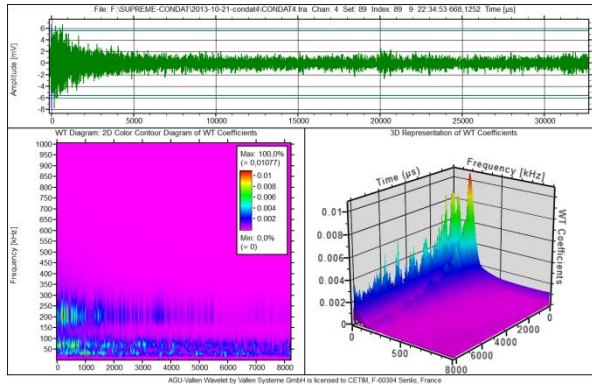
In this first step of the project, we have decided to catch as much as information as possible. Then, some AE hits have been fully recorded. The graph 8 shows a typical AE signal coming from a 200 KHz sensor, and its Wavelet analysis.

Graph 8: AE Waveform – Wavelet analysis

At the moment, it is difficult to say if this type of processing, demanding important needs in term of recording and calculation could improve the diagnosis.

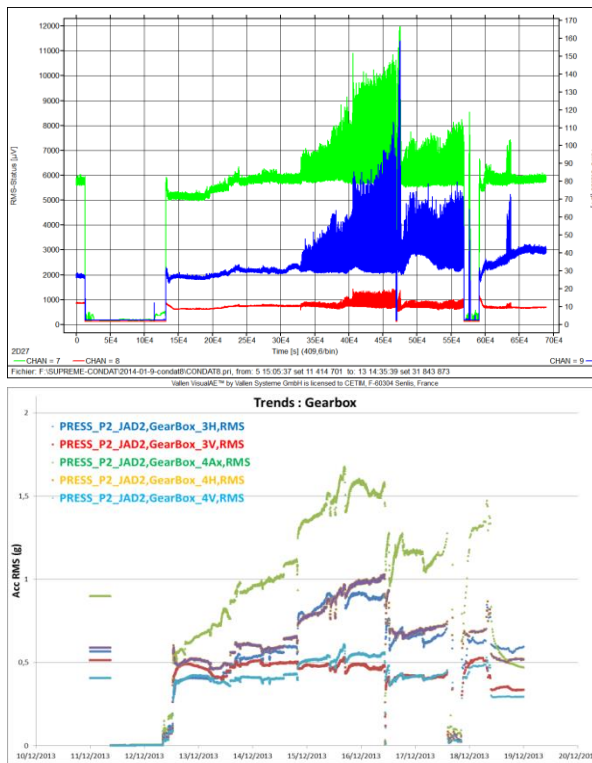
Graph 9 & 10: AE Rms trend and Vibration Rms trend (1 week)

The paper machine has been equipped with different type of sensors, such as vibration sensors, AE sensors, current measurement, torque measurement ... Our objective being to understand the behavior of the machine, and predict any drift of the process, or degradation of a component. Then, we have to cross the information coming from all these sensors. Graph 9 and 10 illustrate a correlation between AE and vibration, on a gearbox.
