Corrosion Evaluation of Glass Fiber Reinforced Plastic (GFRP) Tanks & Pressure Vessels Using Acoustic Emission Technology

Abstract. IREINE project (Innovation for the Reliability of Industrial Equipment) is a study conducted by Arkema, Technip and UTC to develop an innovative NDT (Non Destructive Testing) methodology using acoustic emission (AE) to evaluate active corrosion on Glass Fiber Reinforced Plastic (GFRP) structures. GFRP equipment is widely used in the chemical industry, especially for storage of corrosive products. Failure of such equipment can have important impacts on people safety, environment and production matters. Hence, it is essential to have a technique to ensure reliable detection of damages. The experimental work presented in this paper was aimed at investigating the ability of AE technology for evaluation of corrosion phenomena in GFRP structures. This paper describes the experimental program including field experience on full scale tanks, laboratory results and analysis of the dissection of tank structure.

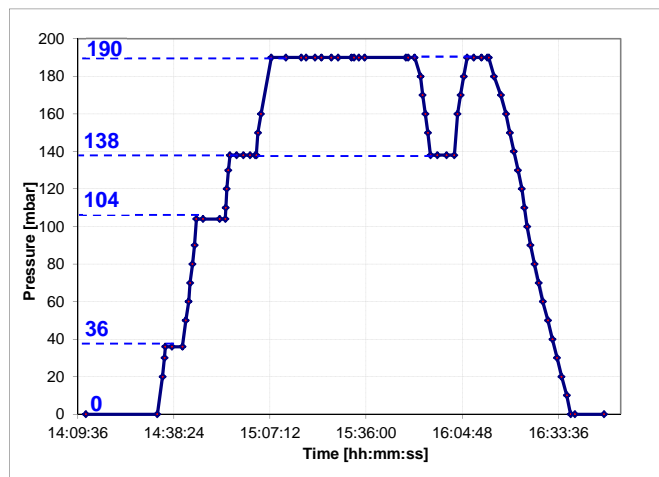
Fig. 5. Loading sequence of the AE proof test on GFRP tank.

For the passive monitoring, the bromine level was held at the in service level (70%) for 2 hours. For the AE proof test, the bromine was replaced with water (for safety reasons). Due to density difference, the water was pressurised up to a P_{max} , pressure equal to 110% of the maximum pressure applied in service. The maximum pressure applied in service is equivalent to the in-service bromine liquid level. Figure 5 shows the loading sequence. The initial hold period (0 mbar) and the hold period at P_{max} (190 mbar) were at least for 30

minutes. The intermediate hold periods were at least for 4 minutes. At the end of the sequence, an unloading followed by a reloading were applied in order to verify the Felicity effect.

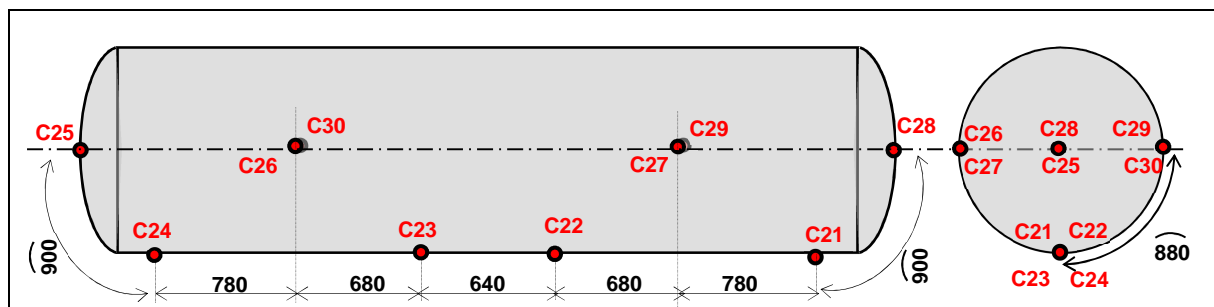
Fig. 6. Sensor layout on GFRP tank for the passive monitoring.

Fig. 6 and 7 show, respectively, the sensor layout on the tank for the passive monitoring and for the proof test. For the passive monitoring, the sensor layout is composed of 10 sensors and aims at covering the portion of the tank in contact with the liquid. For the proof test, the sensor layout is composed of 20 sensors and aims at covering the whole structure of the tank. For both tests, AE signals were recorded with 35dB acquisition threshold; gain of preamplifiers was 34dB; sensors were resonant at around 200 kHz.

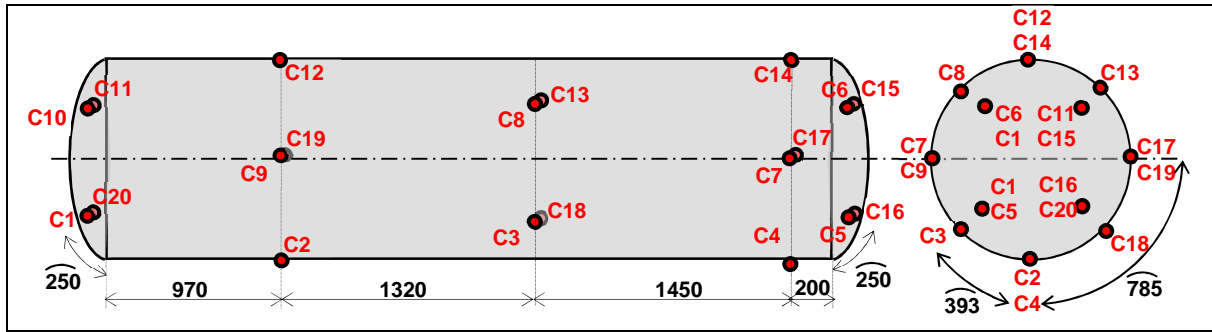
Fig. 7. Sensor layout on GFRP tank for the AE proof test.

Only one zone was classified as minor (sensor 11); all the other areas are classified as insignificant. This means that there is no evolving structural defect affecting the integrity of the tank structure.

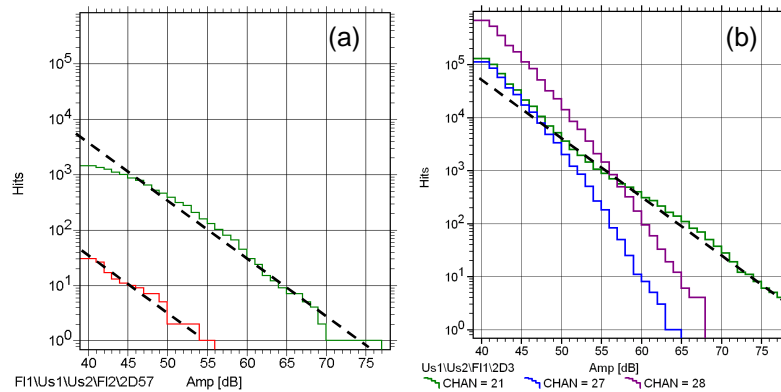
Fig. 12. Cumulative amplitude distributions (a) for the test on specimen (b) for the test on tank

Cumulative amplitude distributions are shown in the figure 12 (Pollock plots). The slopes of these curves are similar for the laboratory test and for the field test. According to Pollock theory, this similarity confirms that the same failure mechanism is detected for both

laboratory and field measurements. Other AE parameters were compared to corroborate this similarity.
